Manhole Inspection Summary

Manhole # S59M__002MH

Insp Date: **11/7/08 11:42 AM**

Location Address: **odonnell st**

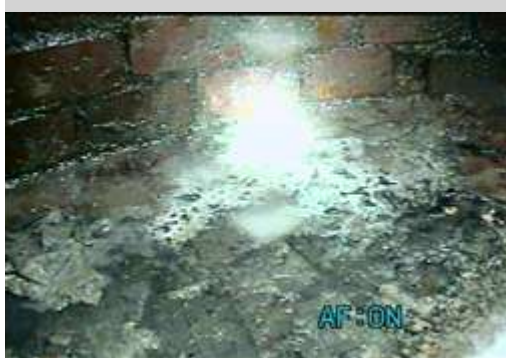
Defect 4

Condition: ☐ Sound ☐ Cracked ☐ Root Intrusion ☐ Deteriorated ☐ Leaks ☒ **Debris**

bench debris

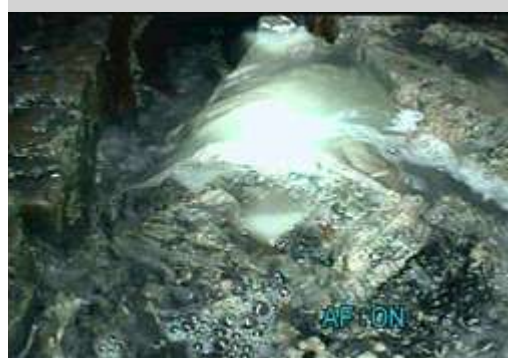
Defect 3

Condition: ☐ Sound ☐ Cracked ☐ Root Intrusion ☐ Deteriorated ☐ Leaks ☒ **Debris**

channel debris

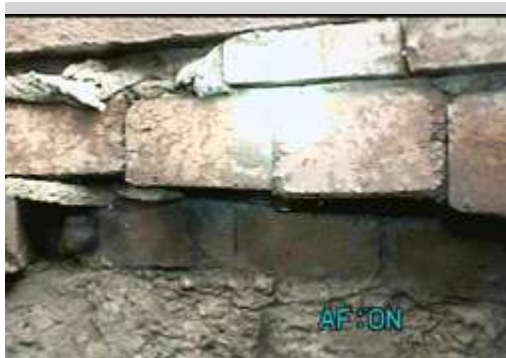
Defect 2

Condition: ☐ Sound ☒ **Cracked** ☐ Root Intrusion ☒ **Loose Brick** ☐ Deteriorated

chimney cracked and loose bricks (frame adj)

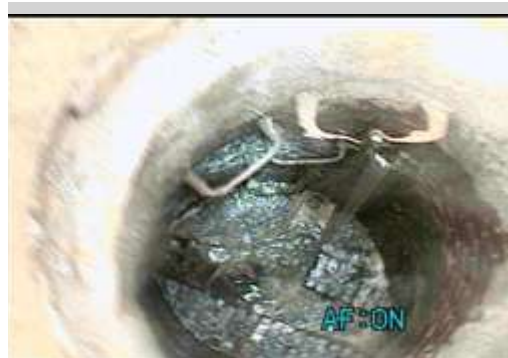
Defect 1

Count: **5** Missing: **1** ☒ **Corroded**

cor. steps

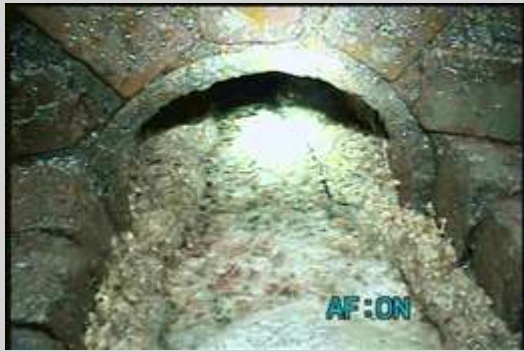
6 O'Clock Inflow

Invert Depth: **9.88** (ft.) Flow Characteristics: **Slow**

Deposits: ☐ None ☐ Mud ☐ Sludge ☐ Debris ☒ **Grease**

Silt Depth: 0 (in.) Deposits Extent: **Heavy**
